# Remediation Strategies and Water Quality of Estuarine Impoundments

Jens Lamping

A thesis submitted in partial fulfilment of the requirements of the Council of the University  
of Durham for the Degree of Doctor of Philosophy (PhD)

### **Remediation Strategies and Water Quality of Estuarine Impoundments**

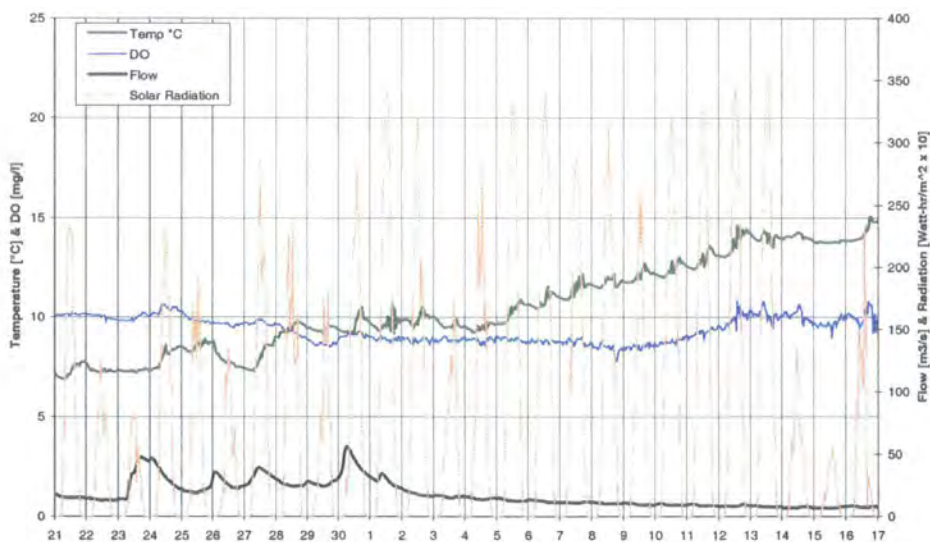
**Figure 5-14 Spring season times series from the Tees impoundment 21/04 – 17/05/01**

Longer periods of radiation levels  $>2000 \text{ Watt-hr/m}^2$  and low flow conditions excluding major events led to an overall warm up of  $>8^\circ\text{C}$  over the course of 27 days in 2001 (Figure 5-14). As seen before, water temperatures under low flow conditions directly represent the daily radiation curve (01 – 12/04/01) as well as the general trend in radiation levels. An additional, interesting, feature is the temperature buffer capacity of the water body observed on the 14/05 and 15/05/01 when a temperature of around  $14^\circ\text{C}$  was maintained despite major decreases in radiation levels. DO levels slightly suffered from the rising

In 2001 and 2002 the period of early spring was characterized by a decrease in major flow events ( $>100 \text{ m}^3/\text{s}$ ), which led to a progression of water temperatures that correlated with the trend in rising radiation levels (Figure 5-14).

The presented time series of water quality recorded in the Tees impoundment for the period 2000-2002 exhibited a high annual as well as flow dependant variability of the observed parameters. Temperature conditions showed a strong correlation with the progression of radiation levels during spring time, which led to rapid warm-up of the impounded water body. Gu and Li (2002) and Webb et al. (2003) suggested that river water temperature is as sensitive to hydraulic loading as to weather conditions depending on the catchment size. However, the reduction of flow velocity and increased residence times in an impoundment generally results in a lower sensitivity towards flow variability as described by Petts (1984) and Churchill and Nicholas (1967). For the Tees impoundment the impact of spring events on the overall temperature increase was found to be only temporary, as documented by the time series showing the arrival of cold-water events (snow melt) in February 2002 (Figure 5-13). Although larger events  $>100 \text{ m}^3/\text{s}$  led to short term cooling in the impoundment, the spring trend in rising temperatures was not considerably affected by the hydraulic charges. Periods of consistent low flows provided the best conditions for a warm up of the impounded water body, as demonstrated in spring 2001, when increasing radiation levels resulted in a rapid diurnal temperature progression (Figure 5-14) of  $>8^\circ\text{C}$  within 27 days.

The significance of the parameter flow was also observed in May 2001, when solar and temperature conditions were already perfect for the existing algae (Figure 5-14) but hydraulic stress possibly prevented a bloom. Once developed, the algal community seems remarkably stable against a series of smaller events but does eventually experience flushing in a larger event as documented by the change in conditions following a 370 m<sup>3</sup>/s event in July 2002 (Figure 5-24). Algae-related diurnal DO variation was replaced by constant conditions for 3 days following this event and up to 10 days following a larger event in June 2000 (Figure 5-16). However, the progression towards super-saturation peaks was also accompanied with major DO and sometimes temperature drops (Figure 5-15) that could not be explained by variations in flow or radiation levels. The regularity of occurrence excludes an instrument failure while nutrient limitation and shading can be ruled out with respect to the further progression of DO levels. The short-term effect suggests an external control such as barrage operation but conductivity records did not indicate excessive saltwater stress via lock operation, which leaves these drops unexplained.

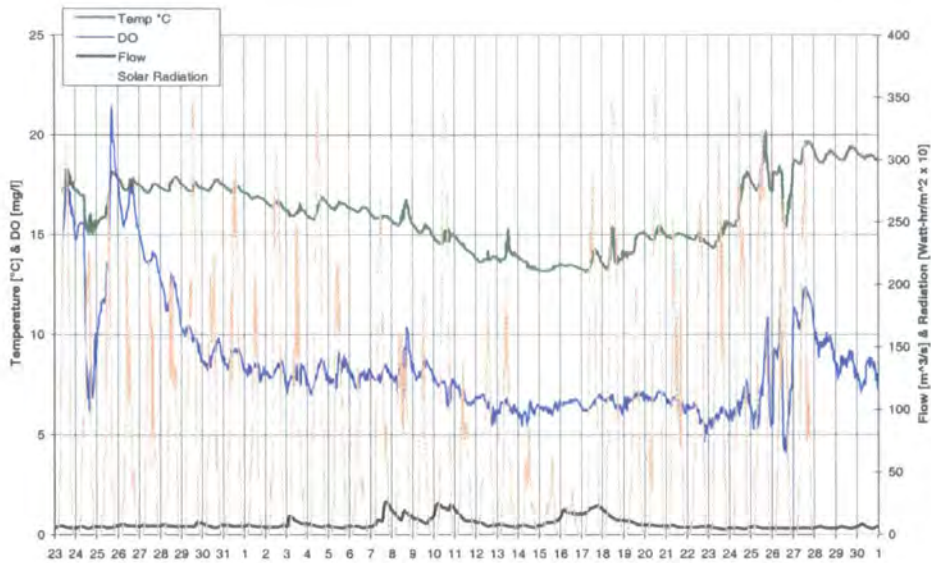
Figure 5-15 Spring season time series of the Tees impoundment 23/05 – 01/07/01

After the hyper-saturation peak, the DO quickly receded to values of 8.15 mg/l (85 %) DO with midday peaks ranging from 0.5 to 1.0 mg/l DO higher. Although conditions were further reduced towards the 5 mg/l mark during the course of the series a second major saturation peak of 12.41 mg/l DO (135.7 %) occurred on the 27/06 at the height of day temperatures (19.62 °C) which was triggered by five days of radiation above 2000 watt-hr/m<sup>2</sup>. Both saturation peaks were accompanied by a large temperature and DO drop unrelated to flow or radiation conditions. Nevertheless, in the absence of flow events the temperature generally described the course of radiation levels and also showed a certain storage capacity during cloudy days (14 - 16/06/01). This also applied to the DO levels which nearly followed the temperature curve although the reverse would be expected considering saturation capacities. Another example of a hyper-saturation event at high water temperatures was recorded for a similar period in 2000 (Figure 5-16).

temperatures but did not fall below 70 % DO saturation. Whereas the first two days in the series still showed constant daily values of around 10 mg/l DO, diurnal variations in DO levels became noticeable from 12/05 onwards which are algae characteristic. Peak levels started to climb in the following weeks of the same year and the yearly maximum of 21.43 mg/l DO (227 %) was reached on the 25/05/01 (Figure 5-15).

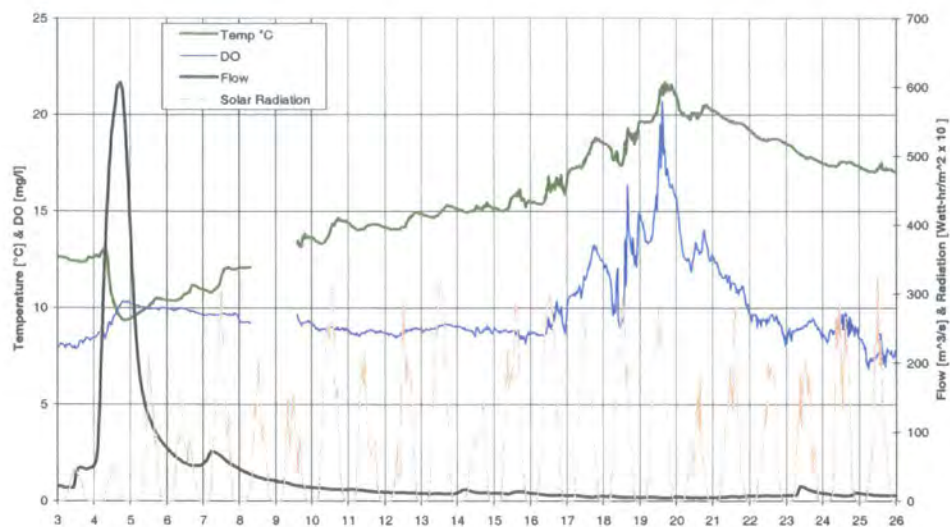
Figure 5-16 Spring season time series for the Tees impoundment 03/06 – 26/06/00

The plot shows the maximum DO concentration recorded in 2000 of 19.51 mg/l DO (221%) occurring at the height of midday water temperatures of around 19 °C. Although the impoundment was initially cooled by the major flow event on the 04/06/01, water temperatures rapidly climbed as a result of the constantly high radiation levels and the quickly receding flows. The actual saturation peak was again preceded by 5 days of high radiation levels  $>2000$  watt-hr/m<sup>2</sup> and accompanied by very low flows (5-6 m<sup>3</sup>/s). The impact of a large event occurring at maximum summer water temperatures ranging around 20 °C was captured in 2002 (Figure 5-17).

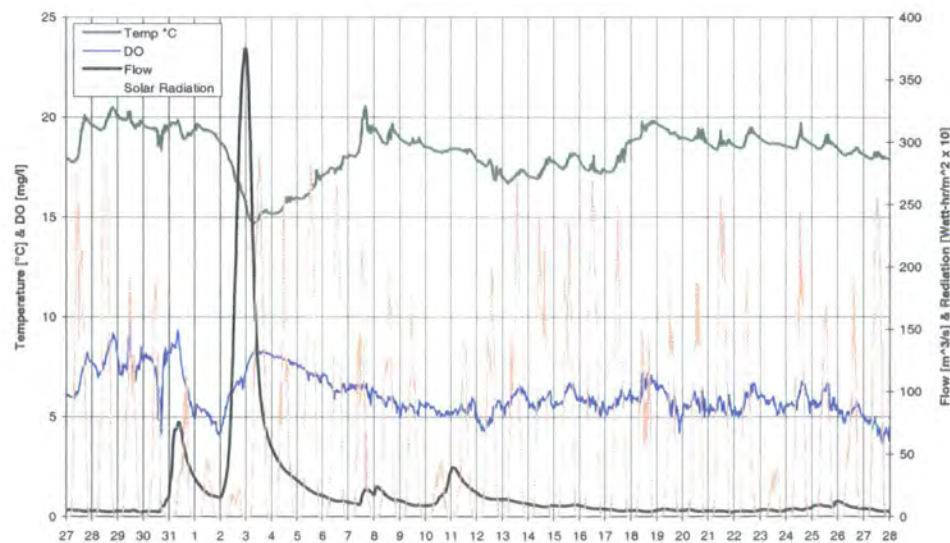
Figure 5-17 Summer season time series of the Tees impoundment 27/07 – 28/08/02

Whilst the preceding small event of  $75 \text{ m}^3/\text{s}$  on the 31/07/02 only had a minor impact on the water temperature, the main flow event of  $375 \text{ m}^3/\text{s}$  on the 02/08/02 led to a temperature drop of more than  $4^\circ\text{C}$  within a few hours. Although, this event was also accompanied by decreasing radiation levels the main cause has to be found in the incoming flow since following radiation drops did not result in similar cooling. Temperature levels did recover within 5 days to initial values of  $20^\circ\text{C}$  as a result of constantly high radiation levels and quickly receding flows. The low flows led to a temperature graph representing the course of radiation levels with afternoon temperature peaks following midday radiation maxima. DO levels before the event showed a large diurnal variation with occasional values dropping below  $5 \text{ mg/l}$  DO. During the event, the DO was restored to constant levels and slightly declined again afterwards as a result of rising water temperature and receding flows. However, DO values did not show significant diurnal variation for a period of 3-4 days following the event. With the restoration of initial temperatures and low flows, daily DO variations started again and levels were further reduced with lows  $<5 \text{ mg/l}$  DO on several occasions. By the end of the summer the  $5 \text{ mg/l}$  DO mark was breached several times during the years 2001 and 2002 (compare section 5.3.2.2). In 2002 conditions at the end of the summer severely deteriorated as a result of absent fluvial exchange within the impoundment (Figure 5-18).

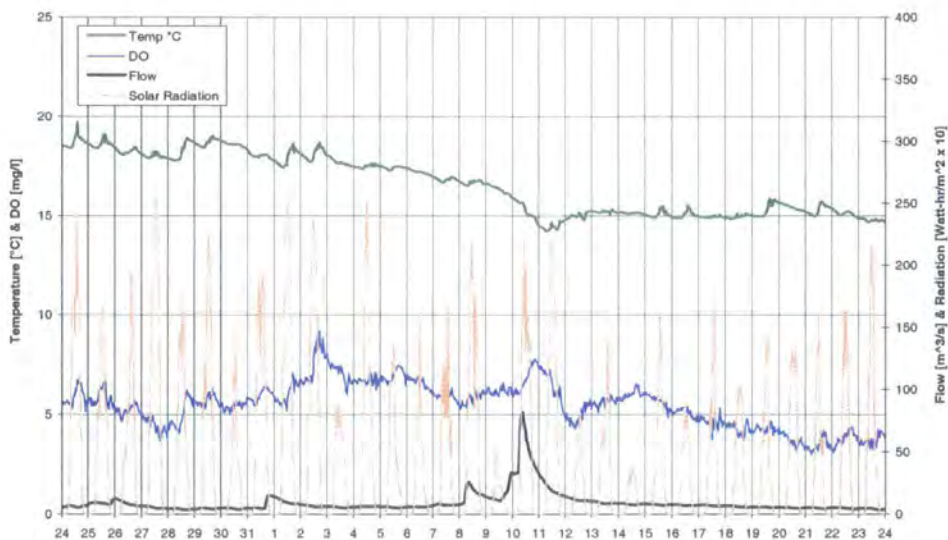
Figure 5-18 Summer season time series from the Tees impoundment 24/08 – 24/09/02

Only the minor event on the 11/09/02 with a maximum of  $80 \text{ m}^3/\text{s}$  provided a slight cooling and raised DO levels but did not have a lasting effect on the reduced conditions. Levels remained below values of  $5 \text{ mg/l}$  DO for periods of two days on the 27/08 and

28/08/02. Although temperatures decreased, a long-term breach of the 5 mg/l DO mark started on the 17/09/02. The end of the low summer conditions in 2000 was marked by the arrival of a series of high flow events (Figure 5-19).

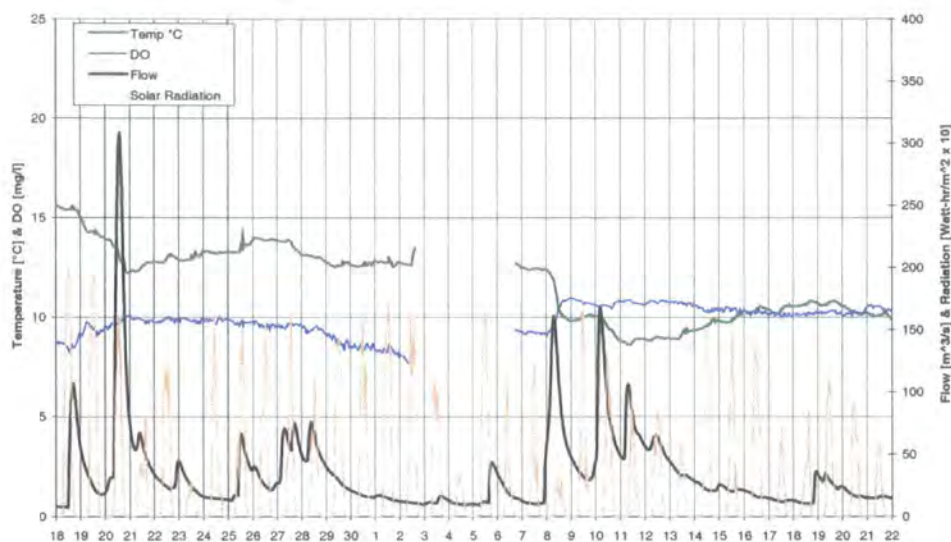
Figure 5-19 Autumn season time series in the Tees impoundment 18/09 – 22/10/00

With the general decline of radiation levels the impoundment seemed more sensitive to riverine inputs as documented in the temperature drops introduced by the events on the 18/09/ and 20/09/00 as well as the impact observed by the smaller events on the 08/10, 10/10/ and 11/10/00. The overall temperature drop of 6.76 °C was buffered after each event during recession flows which suggests that the observed radiation levels would have maintained a higher water temperature under low flow conditions. The DO was restored to values above 10 mg/l DO as part of the introduced temperature drops and the algae characteristic diurnal variations were replaced by constant daily levels after the second series of events on the 12/10/00. The end of summer conditions and the occurrence of the first larger flow event was also recorded in October 2002 when DO values were already slightly increased beforehand due to falling water temperatures (Figure 5-20).

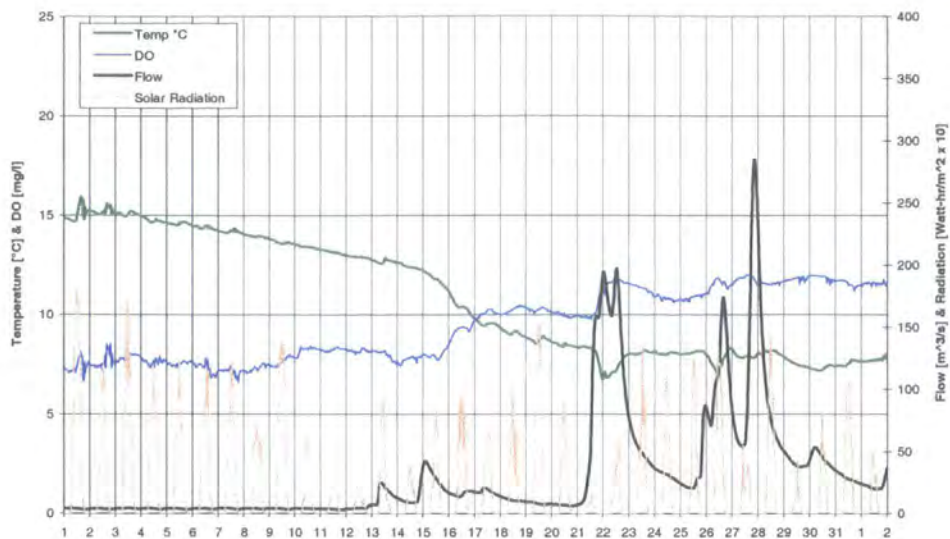
Figure 5-20 Autumn season weekly time series for the Tees impoundment 01/10 – 02/11/02

The events on the 21/10 and 26/10/02 introduced a temporary drop in temperature while the main cooling was related to the radiation curve. As the high flows declined temperature returned to the preceding values. Although the water temperature was restored to a value similar prior to the event on the 21/10/02, DO levels remained constantly high at 10.72 mg/l DO (91 %) as a result of the freshwater input. The largest event on the 27/10/02 did not demonstrate an immediate impact on water temperature suggesting a different source to the foregoing events. Finally, the effect of larger events during winter time is demonstrated by the time series recorded in 2000 (Figure 5-21).

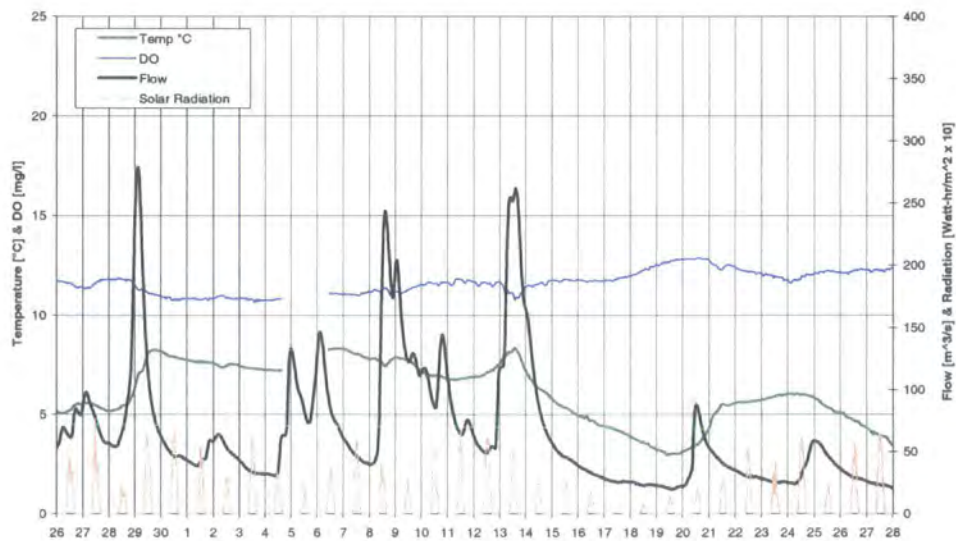
Figure 5-21 Winter season time series of the Tees impoundment 26/11 – 28/12/00

The record shows a temperature increase of  $>3^{\circ}\text{C}$  during a series of large events which can not be related to variation in radiation levels. Temperature peaks following (29/11/00) or coinciding (13/12/00) with flow peaks indicate a warmer riverine input to the impoundment which maintains a slightly elevated temperature. With declining flows and dropping radiation levels the temperature falls rapidly until increasing radiation levels initiate another warm up of the impoundment. DO levels are consistently high during this season and variations result from the progression of temperature as indicated by the drop on the 13/12/00 and the higher values on the 19/12/00.

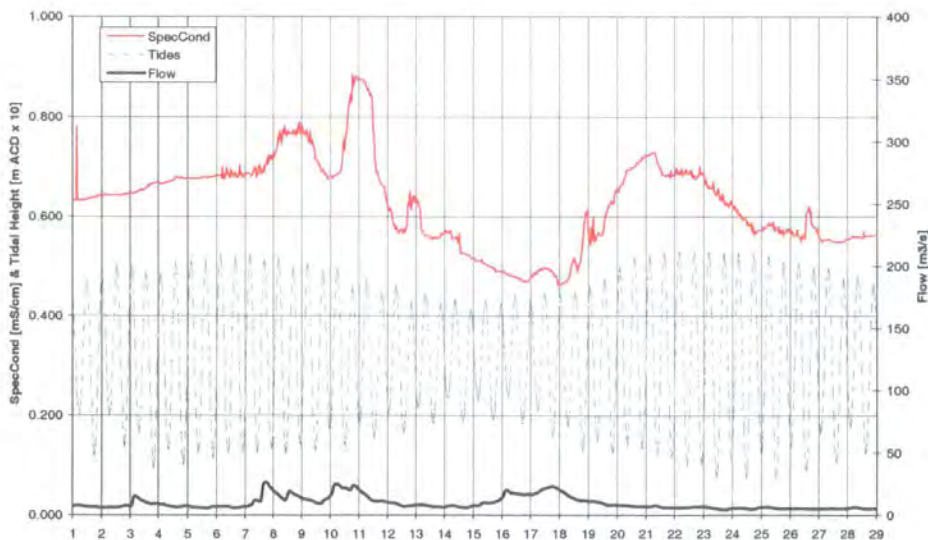
**Figure 5-22 Spring season time series of conductivity for the Tees impoundment 01/06 – 29/06/01**

When compared to the tidal frame of that period, an underlying correspondence in the overall trend of highest high water levels and conductance seems noticeable. However, the conductance peaks recorded on the 09/06/, 10/06/ and 12/06/01 cannot be related to the tidal frame nor to variations in flow. The dilution effect of larger events on conductivity

The episodic pattern of specific conductance depressions associated with higher flows throughout the annual time series suggests the need to focus on event based variability rather than the seasonal variability. Conditions recorded during a series of minor flow elevations in June 2001 show no direct relationship between the hydrograph and conductivity levels (Figure 5-22).

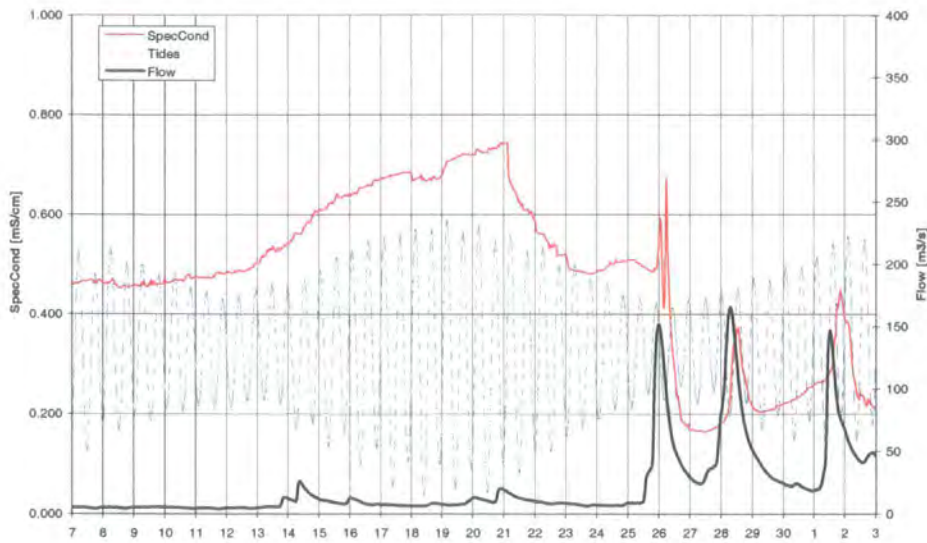
**Figure 5-23 Autumn time series of conductivity for the Tees impoundment 07/09 – 03/10/01**

A slow increase in EC levels is indicated for the low flow conditions preceding the events with a major drop occurring on the 21/09/01 that is unrelated to variations in flow. However, the following three events on the 21/09, 28/09 and 01/10/01 lead to EC peaks that slightly lag the flow peak by about 6-10 hours. Despite their initial ionic load the events lead to an overall dilution of EC within the impoundment.

was monitored on several occasions as illustrated by a series of events that occurred during September/October 2001 (Figure 5-23).

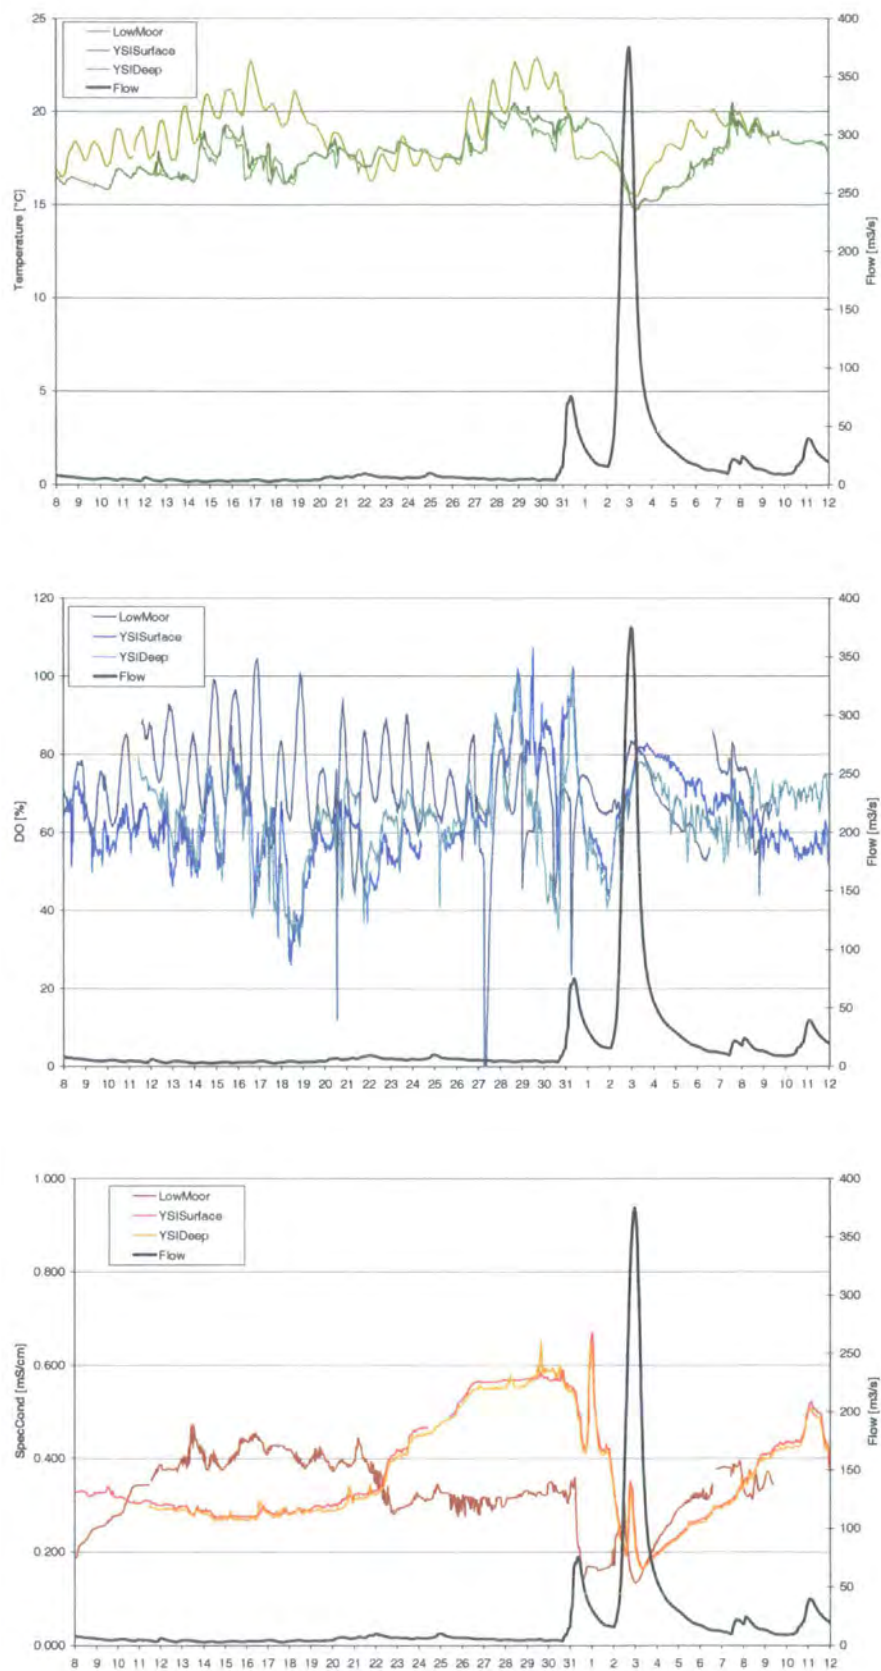
Figure 5-24 Summer event time series of a) Temperature, b) DO and c) SpecConductance 08/07 – 12/08/02 for Low Moor and Tees Barrage

Diurnal progressive temperature variation is indicated for the low flow conditions preceding the event. The surface and deep record from the impoundment does not show a temperature or DO difference during the warm up. The upstream source at Low Moor exhibits a larger diurnal variation and higher levels in temperature and DO compared to the records taken at the barrage. DO conditions at the barrage suffer considerably on the 19/07 and on the 21/07 while levels at the upstream source still show a diurnal range from 65 to 100 % DO saturation during low flows and high temperatures  $>16^{\circ}\text{C}$ . The peak preceding the main event leads to a major drop in temperatures of  $>3^{\circ}\text{C}$  at the upstream source whereas the impoundment only experienced a minor temperature change of  $0.5^{\circ}\text{C}$ . The main peak resulted in a rapid temperature decrease at the barrage which even exceeded the lowest value at the upstream station by  $1^{\circ}\text{C}$ . Temperatures climbed quickly at the Low Moor station whereas the impoundment buffered an increase slightly up until the 07/08 when initial values above  $20^{\circ}\text{C}$  were reached again. DO conditions at the barrage showed characteristic, algae-related, diurnal variation before the event with deteriorating levels throughout the water column. Rising radiation levels and temperatures from the 26/07 onwards led to increased photosynthetic activity at the surface of the impoundment with levels quickly reaching 107 % DO saturation while deep levels dropped to 40 %. The arrival of the first smaller peak of the event on the 31/07 provided mixing within the impoundment and equalized the DO gap within the water column. However, temperatures were still high at  $>19^{\circ}\text{C}$  and the recession of flows led to a major drop in DO levels at the barrage. The second larger peak of the event restored DO conditions to values equal to the upstream levels of  $>80$  %. Diurnal temperature and DO variation disappeared at both stations during the course of the event and reappeared again 3-4 days later (also compare Figure 5-17). The readings for EC during July indicate that the low flows initially carried a high ionic load ( $0.4\text{ mS/cm}$ ) which was then slowly accumulated within the impoundment whereas levels at the upstream end declined with the slight increase of flows from the 22/07 onwards. EC accumulation at the barrage reached highest levels of around  $0.6\text{ mS/cm}$  on the 30/07 and experienced rapid dilution to levels below  $0.2\text{ mS/cm}$  during the course of the events. Although upstream levels indicated low input concentrations of the discharges the arrival of the quickflow component at the barrage was accompanied by conductivity peaks. With the quick recession of flows after the floods EC accumulation started again accompanied by smaller events entering the impoundment.

column. Water quality records at the upstream monitoring station indicated considerably higher DO levels throughout the summer of 2002 (Figure 5-24 & Figure 5-25) since sedimentation rates and sediment oxygen demand are lower within the flowing stream. Nevertheless, these DO enriched inputs did not lead to raised DO levels at the barrage since they only contributed a minor proportion to the impoundment volume. The DO levels at the barrage were on average 17.15% lower during dry conditions (Q75) and 9.6% lower for higher flows.

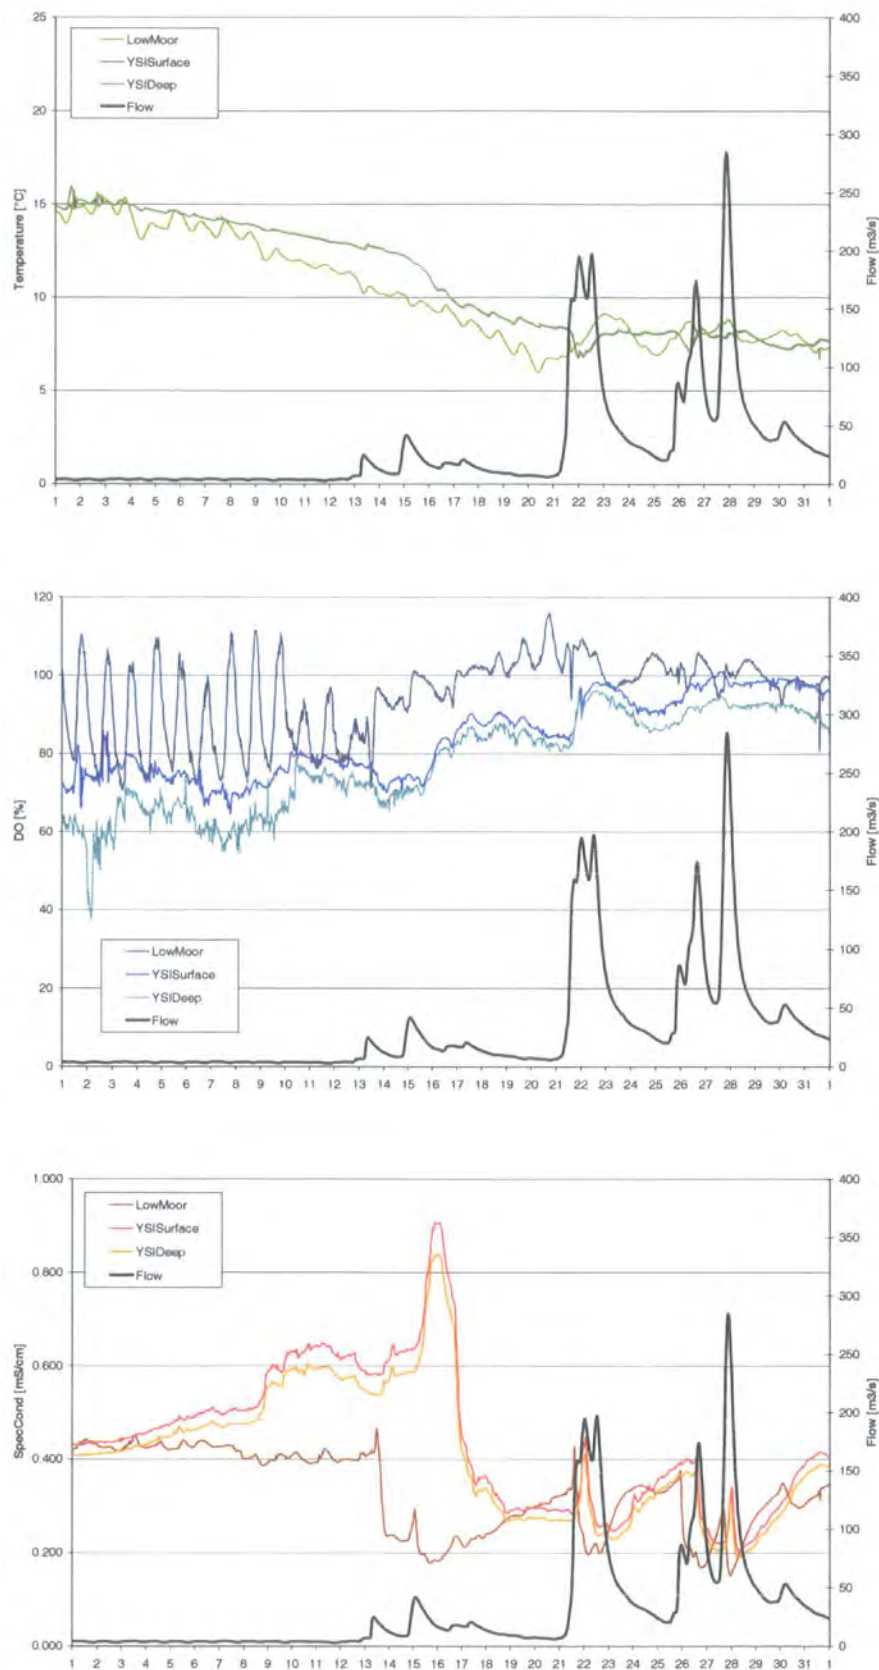
Figure 5-25 Autumn event time series of a) Temperature, b) DO and c) SpecConductance for Low Moor and Tees Barrage 01/10 – 01/11/02

The record initially illustrates the characteristic diurnal summer variation of DO levels under low flow conditions, which again is more pronounced at the upstream end although temperature variation decreased compared to the July record. With the introduction of the first slight elevation in discharges from the 13/08/02 onwards the daily DO variations became less pronounced and temperatures dropped steadily. Conditions in the impoundment initially lagged behind in terms of temperature and DO but equalized with the arrival of the first major peak flow on the 22/10/02. Constant daily DO levels predominated the impoundment from then on although the upstream end still showed slight diurnal variations up until mid-November. Conductivity values at the barrage exhibited an extraordinary ion load ( $>0.9$  mS/cm) associated with two minor events entering the impoundment after a month of dry and hot conditions. Upstream levels show EC dilution during these events which quickly followed after the peak levels measured on 16/07/02. The following series of larger events also exhibited EC peaks on their quickflow components but did not further dilute EC during baseflow due to the already low levels of  $<0.3$  mS/cm. Instead accumulation started again on the recession of flows.

Conditions only started to improve with increasing flow rates and declining water temperatures during autumn of each year. In 2002, these urgently required flow elevations were delayed until mid-October (Figure 5-25), thus prolonging the period of DO depletion. On their arrival, conditions quickly equalized with upstream levels of temperature and DO saturation. The flow events also resulted in a flushing of algae at the barrage since diurnal DO variations disappeared in the impoundment whereas levels at the upstream end still showed daily variations.

The lag in temperature and the buffer capacity against small event extremes is lifted with the arrival of larger flushing events as seen in July and October 2002 (Figure 5-25) when barrage temperatures quickly reflected the recordings taken at the upstream end. As well as the impounded water volume buffers against warm water extremes it also reduces the cooling impact of inputs and thereby maintains higher water temperatures at the end of the summer (Figure 5-25). With reference to the increased biological activity and lower DO saturation rates this has to be rated as a negative side effect of the barrage.

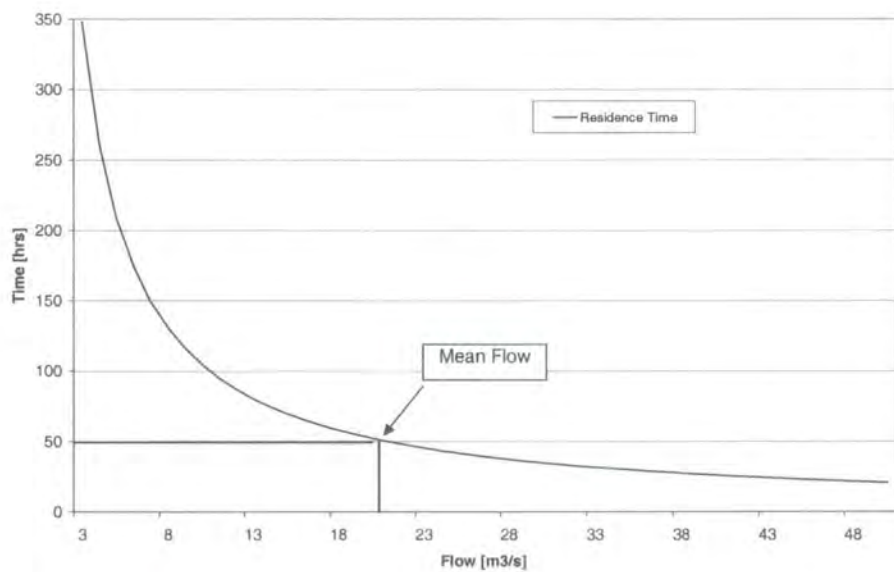
Figure 5-27 Q95 to Q10 Flow range vs residence time in the Tees impoundment

As a result of the water storage, flow velocities decrease towards the barrage and residence time increases. The retention time of neutral water particle within the 12 km stretch for a mean daily flow of  $20.72 \text{ m}^3/\text{s}$  (50 percentile-Figure 5-7) is prolonged to 50 hrs (Figure 5-27). It is not possible at this stage to estimate the pre-barrage conditions.

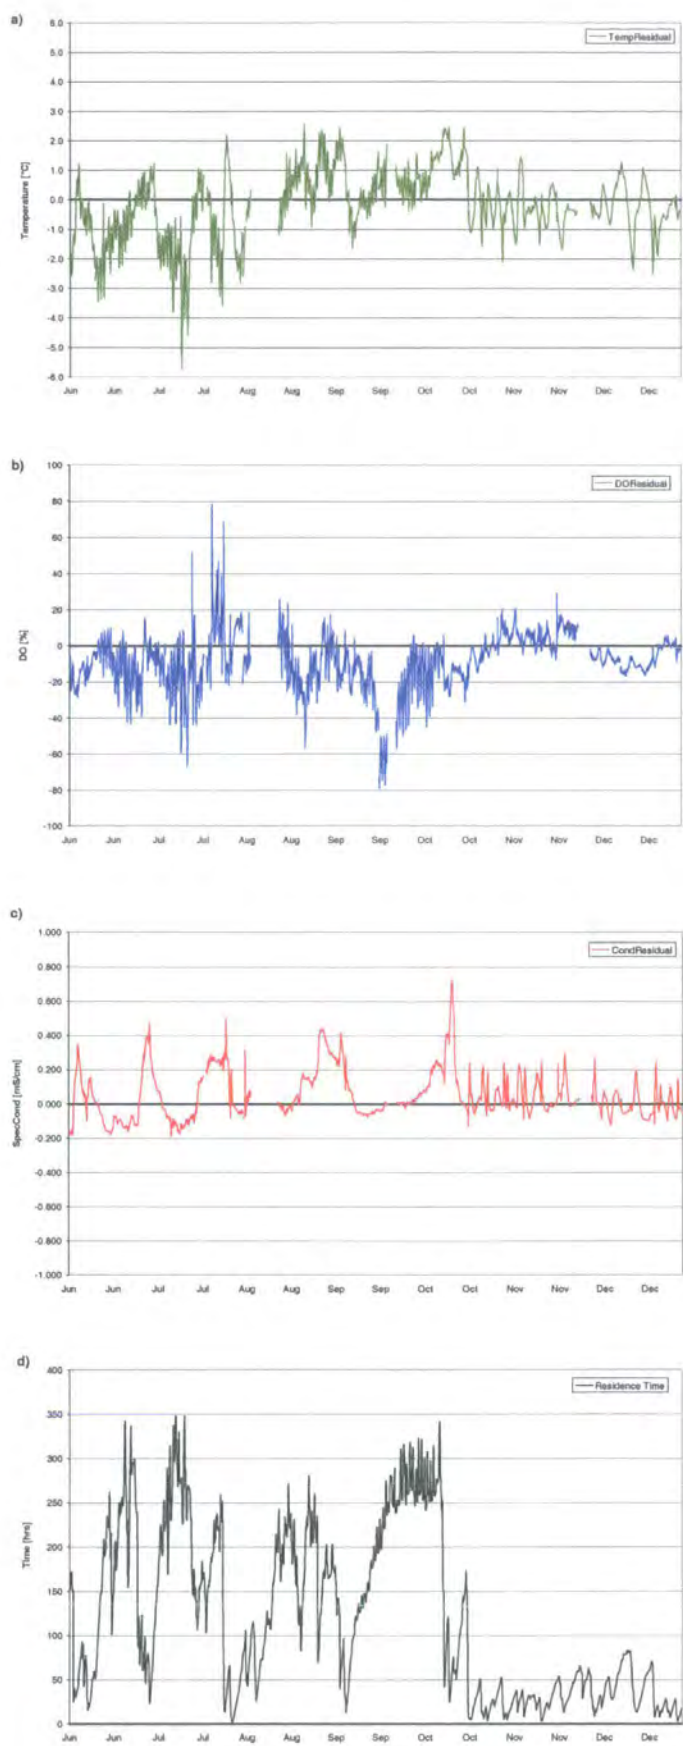
Figure 5-28 Residual time series for a) Temperature, b) DO and c) SpecConductance between Low Moor and Tees Barrage vs d) Residence Time

Residence times above 200 hrs occurred regularly during the summer months in 2002 as a result of low flows (Figure 5-28-d). The temperature residual (Figure 5-28-a) indicates that the longer retention time can result in a temperature increase of 2.0 °C compared to the upstream source. Flow spates reversed the conditions, since the temperature response is quicker at the upstream source, which led to negative residuals of up to – 5.0 °C for short residence times below 100 hrs. The DO conditions at the barrage showed a general decline towards the end of the summer months with average removal rates between 20 and 40% for residence times above 200 hrs (Figure 5-28-b). Large variation and positive residuals occurred during the summer due to increased in algal activity. As already demonstrated in the previous section, an accumulation of conductivity (+ 0.2 mS/cm) occurs under low flow conditions at the barrage when residence times exceed 200 hrs (Figure 5-28-c). However, the runoff component of flow spates also led to peak residuals of >0.4 mS/cm which is illustrated for most of the residence times below 50 hrs throughout the summer period. From mid-October onwards the regular occurrence of flow spates decreased the retention period below 50 hrs, which resulted in much lower residuals for DO and Conductivity. Temperature residuals, however, still demonstrated a large variation due to the rapid response of stream-water temperature at the source compared to a slower impact at the barrage.

The extended residence time affects the measured water quality parameters, which can be defined as the residual between the source (Low Moor) and the impoundment (Barrage YSI) readings (Figure 5-28 a-c).

On average, the barrage increases water temperature by 0.58 °C and reduces the oxygen levels by 17.15 % during low flow (Q75) conditions. For higher flows, the temperature effect becomes negligible, but DO still shows 9.61% lower values than the upstream
